Asset Insight Report Demo 198

Transformer Details

LOCATION	SENSOR ID	NAME PLATE AGE
Unspecified	No sensor installed	34

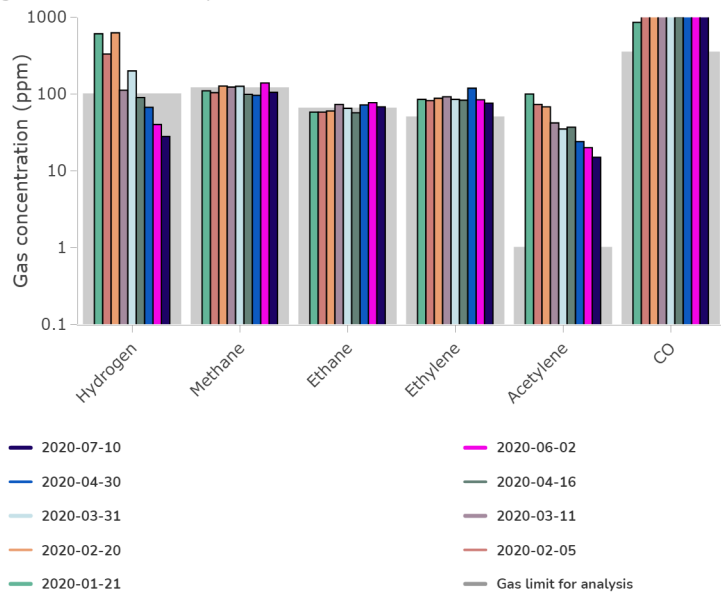
Rogers Gas Limit Analysis

CONCERN	CONDITION INDEX	DATE OF EVENT
Significant Levels of Acetylene (C2H2) : 14ppm D	Dielectric D	12-Jan-2022

Threshold: 11 ppm

The transformer is generating significant levels of a very dangerous gas which indicates a dangerous fault.

Immediately consider the removal of the transformer from service and implement a program of diagnosis to assess the possibility of repair or need for emergency replacement.

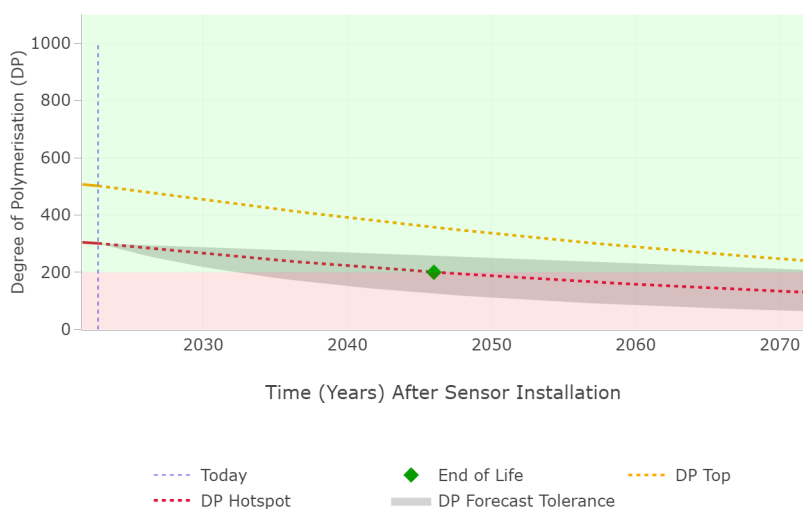
DP Forecast

Low DP : 387 **C**

Threshold: ≤ 400 DP

The Transformer has degraded cellulose insulation DP (Degree of Polymerization). Low DP paper has poor mechanical strength and this can result in cracks, voids, and poor interwinding separation strength.

The transformer is aged but best practice indicates it still has useful life (in the absence of other fault signatures). That life can be maximized and the replacement date delayed by ensuring moisture levels are low, periods of high (near nameplate load) is minimized, and the cooling system (including oil) is serviced for maximum efficiency. Due to the aging state of the transformer insulation, a careful approach should be taken when interpreting other signs of partial discharge, arcing, or vibration.

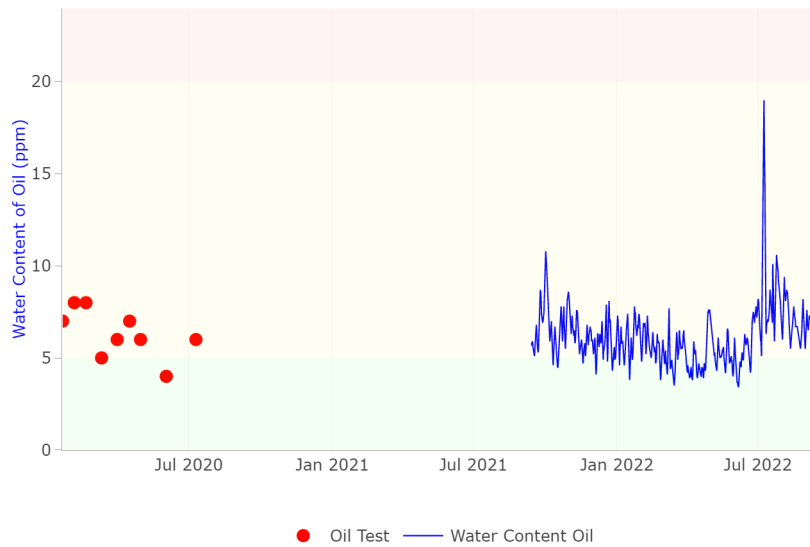
Water Content of Oil

Poor Insulation Quality **C**

The combination of elevated moisture and acidity contaminating the oil likely indicates a poor state of the insulating qualities of the oil. This can lead to partial discharge and load stress-related failure.
Poor condition of the cellulose insulation may increase these risks as the Degree of Polymerization drops below 400 DP.

Consider the assessment of the power factor, dissipation factor, and dielectric response factor of the transformer insulation and implement refurbishment as necessary (drying, oil replacement or refurbishment) to protect the remaining life of the transformer.

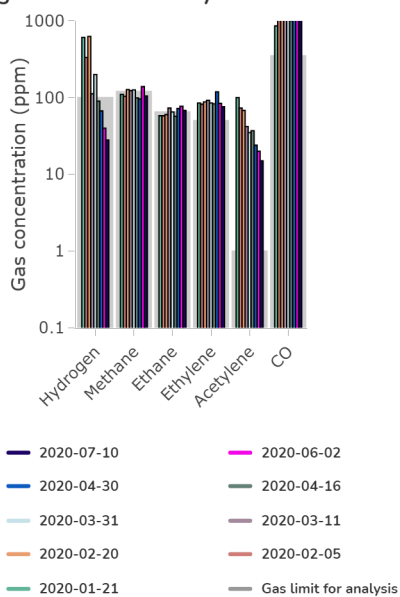
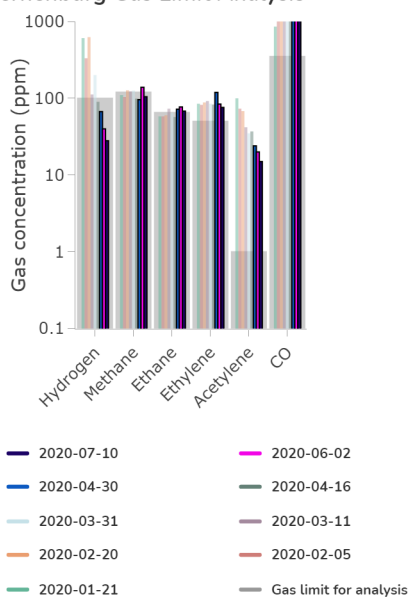
Significant Levels of Carbon Monoxide (CO) : 1107ppm **C**

Threshold: 570 ppm

The transformer is generating gas which indicates hot temperature oxidization of the cellulose insulation. This could be the result of overloading or the development of a cooling problem (such as blocked oil ducts). It may also be the early signs of a serious fault in the core.

Analysis of the cause of gassing is recommended and any necessary rectification works completed in order to protect the remaining life of the transformer. This should be done in a timely way, possibly before the next scheduled rectification works.

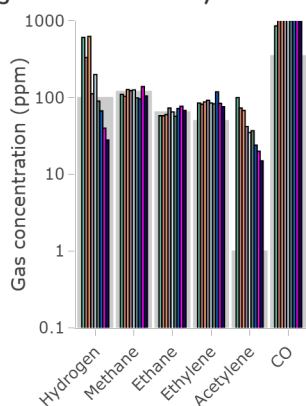
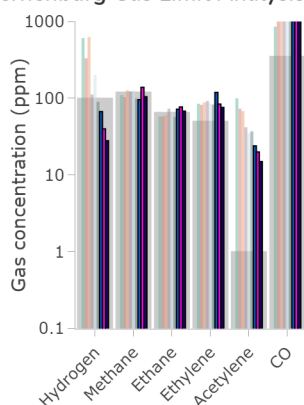
Significant Levels of Carbon Dioxide (CO2) : 9779ppm **C**

Threshold: 4000 ppm

The transformer is generating gas which indicates hot temperature oxidization of the cellulose insulation. This could be the result of overloading or the development of a cooling problem (such as blocked oil ducts). It may also be the early signs of a serious fault in the core.

Analysis of the cause of gassing is recommended and any necessary rectification works completed in order to completely protect the remaining life of the transformer. This should be done in a timely way, possibly before the next scheduled rectification works.

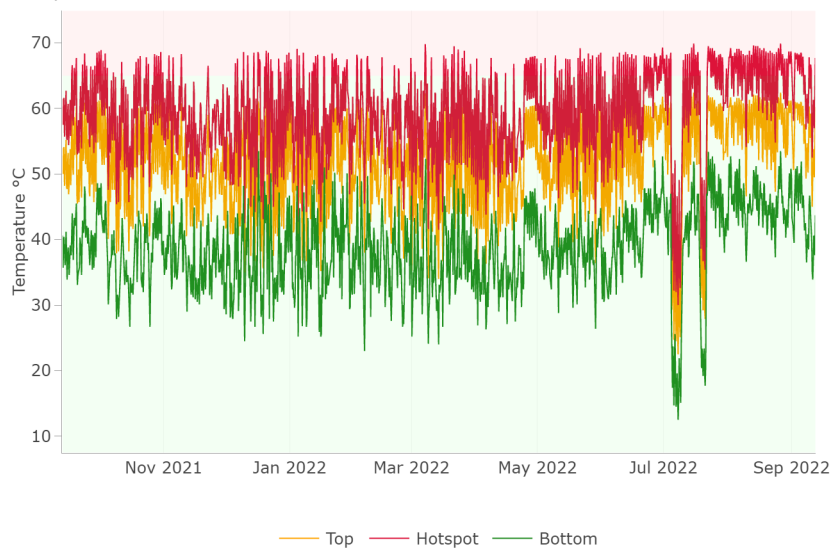
Temperature Profile

High Hot Spot Temperature : 70.6°C **B**

Threshold: DP > 350 80°C for Kraft, 110°C for TUK
 DP ≤ 350 70°C for Kraft, 100°C for TUK
 DP ≤ 200 60°C for Kraft, 90°C for TUK

High hot spot temperatures place the transformer at risk of moisture droplets and bubbling, plus accelerated aging. High hot spot temperature can be caused by excessive load, extreme ambient conditions, or poor cooling system performance.

The transformer's cellulose insulation is badly degraded. DP is less than 350 (DP = 301) and because of this the risk index for 'High Hot Spot Temperature' has been adjusted.

Analyze the root cause of the high hot spot temperatures and rectify in order to protect the remaining life of the transformer.

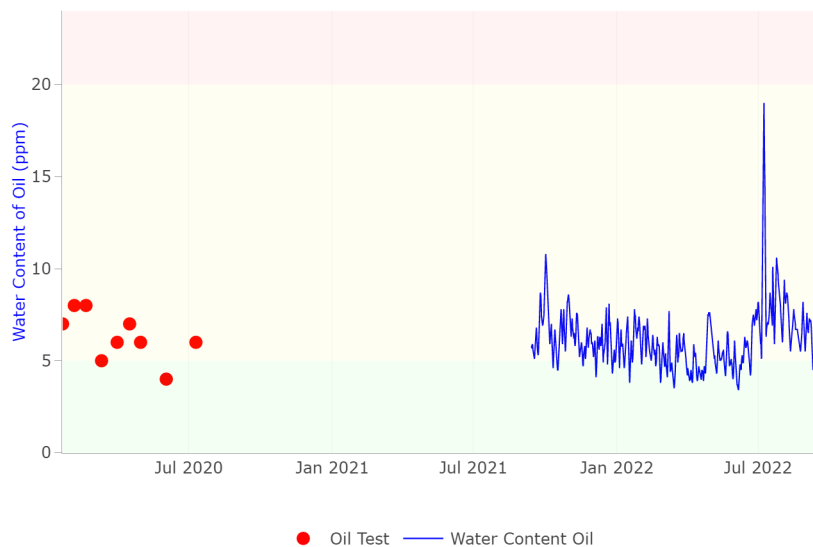
High Water Content of Oil : 19ppm **B**

Threshold: DP > 350 20 ppm
DP ≤ 350 15 ppm
DP ≤ 200 10 ppm

Periods of moderate to high water content of the oil are being observed where the insulation breakdown strength will be reduced to 75% of normal. High moisture in oil often occurs when the operating temperature of a wet transformer falls quickly after a period of high load.

The transformer's cellulose insulation is badly degraded. DP is less than 350 (DP = 301) and because of this the risk index for 'High Water Content of Oil' has been adjusted.

Monitor WCO closely and consider drying. Consider changing load management procedures to prevent fast temperature drops after periods of high load.

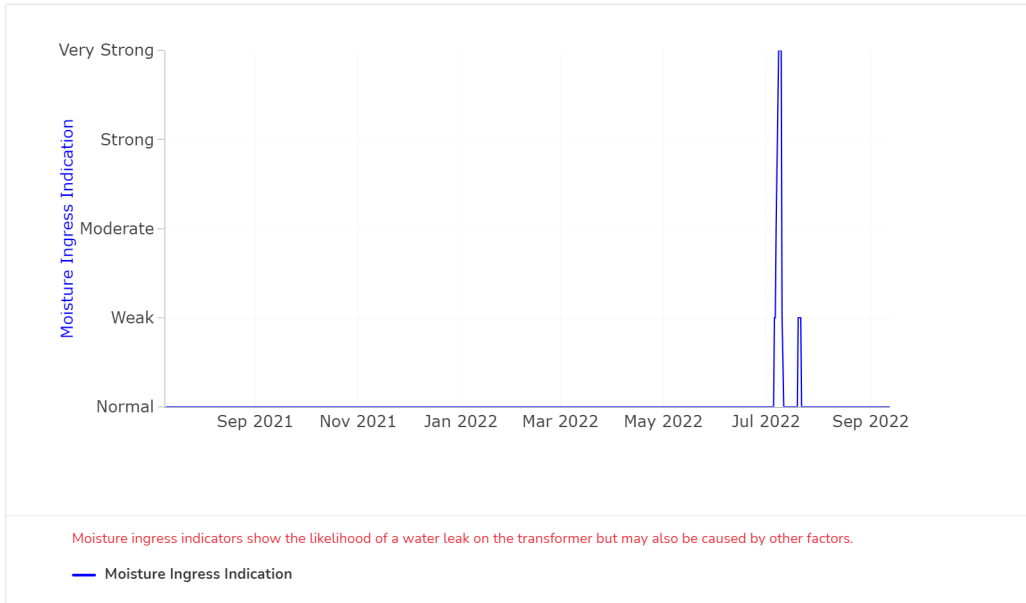
Moisture Ingress in Oil Indication

Moisture ingress indicators show the likelihood of a water leak on the transformer but may also be caused by other factors.
