Asset Insight Report Demo 198

Transformer Details

LOCATION	SENSOR ID	NAME PLATE AGE
Unspecified	No sensor installed	34

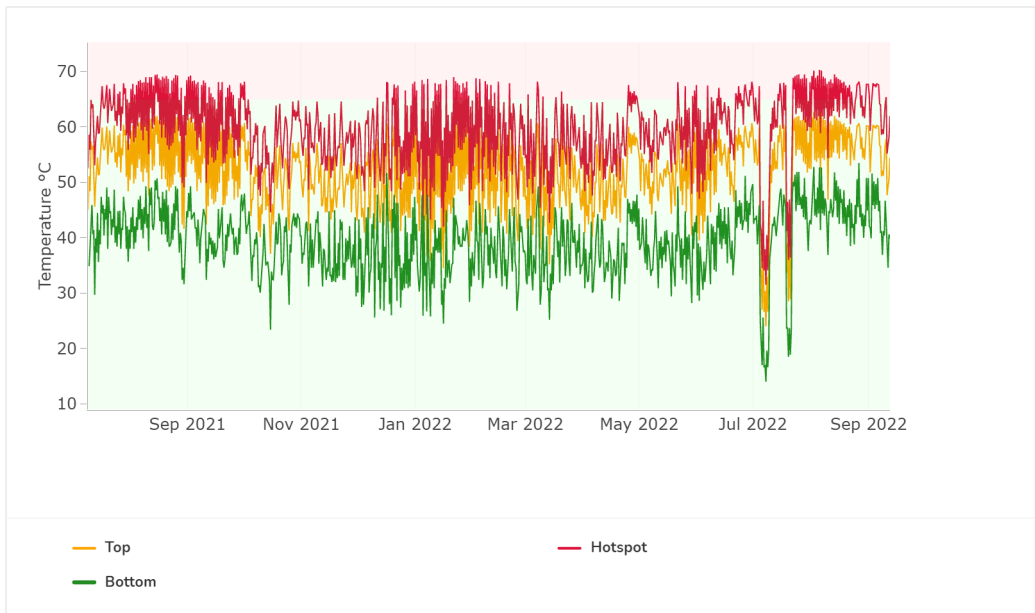
Temperature Profile

High hot spot temperatures place the transformer at risk of moisture droplets and bubbling, plus accelerated aging. High hot spot temperature can be caused by excessive load, extreme ambient conditions, or poor cooling system performance.

The transformer's cellulose insulation is badly degraded. DP is less than 350 (DP = 301) and because of this the risk index for 'High Hot Spot Temperature' has been adjusted.

Analyze the root cause of the high hot spot temperatures and rectify in order to protect the remaining life of the transformer.

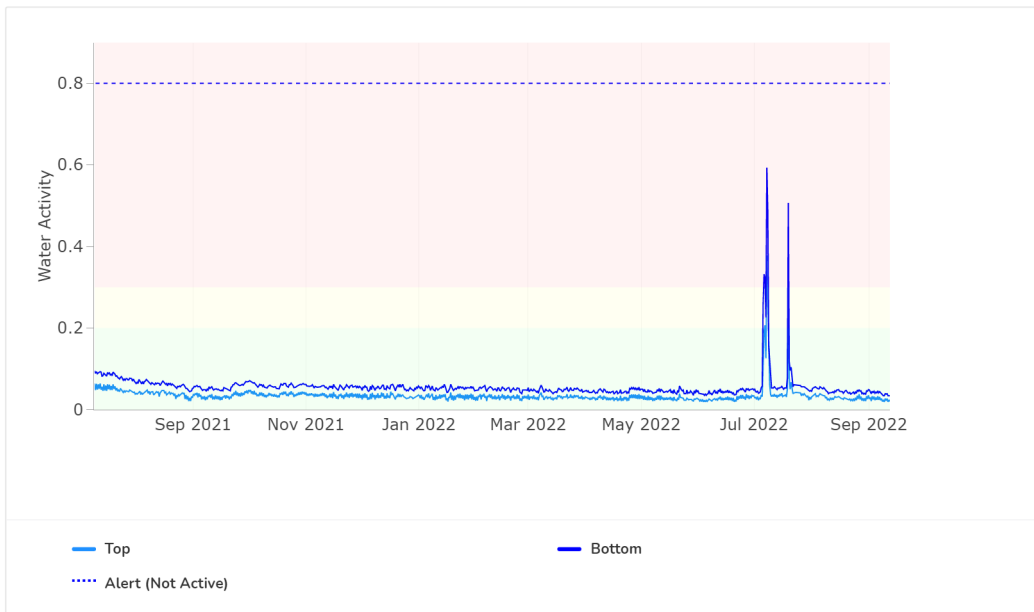
Water Activity Profile

Periods of moderate to high water content of the oil are being observed where the insulation breakdown strength will be reduced to 75% of normal. High moisture in oil often occurs when the operating temperature of a wet transformer falls quickly after a period of high load.

The transformer's cellulose insulation is badly degraded. DP is less than 350 (DP = 301) and because of this the risk index for 'High Water Content of Oil' has been adjusted.

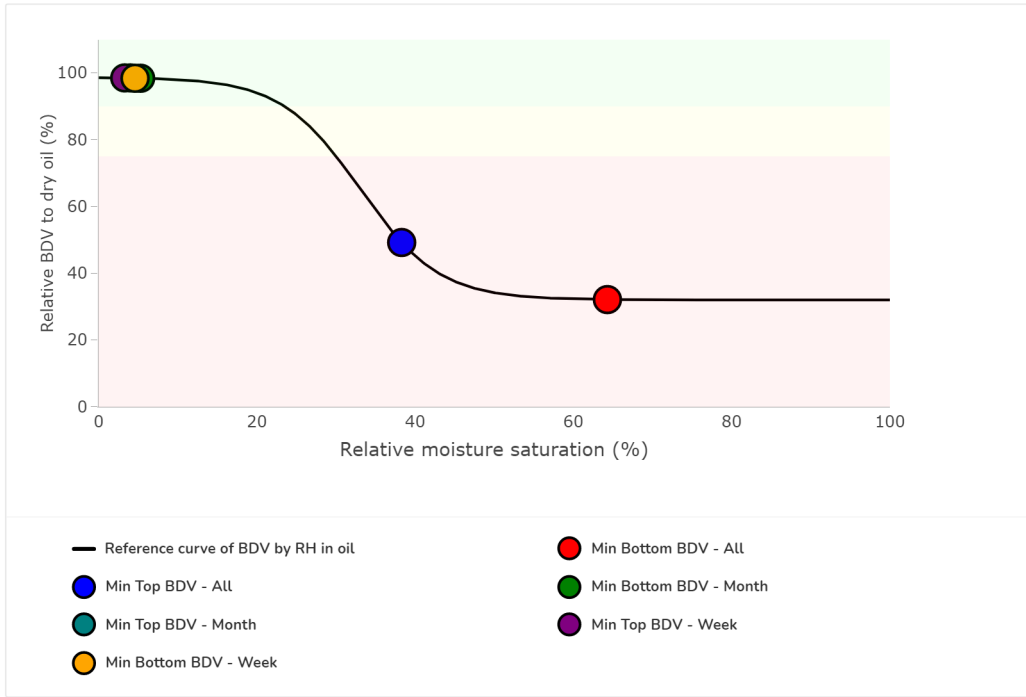
Minimum Breakdown Voltage

Oil test results indicate a low breakdown voltage, likely due to contamination in the oil (moisture or breakdown products). It indicates aging or degraded oil performance and should be carefully monitored.

The transformer's cellulose insulation is badly degraded. DP is less than 350 (DP = 301) and because of this the risk index for 'Low Breakdown Voltage of Oil (BDV)' has been adjusted.

Continue to monitor the state of the oil insulation. Review the partial discharge state of the transformer as low BDV of the oil can cause accelerated PD development.

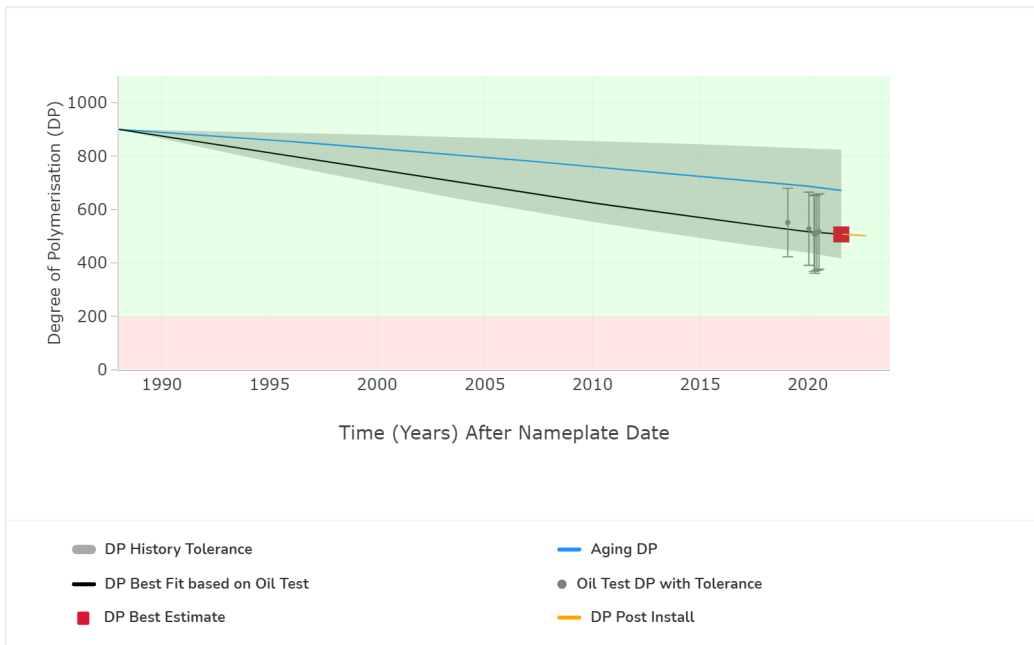
DP History

The Transformer has degraded cellulose insulation DP (Degree of Polymerization). Low DP paper has poor mechanical strength and this can result in cracks, voids, and poor interwinding separation strength.

The transformer is aged but best practice indicates it still has useful life (in the absence of other fault signatures). That life can be maximized and the replacement date delayed by ensuring moisture levels are low, periods of high (near nameplate load) is minimized, and the cooling system (including oil) is serviced for maximum efficiency. Due to the aging state of the transformer insulation, a careful approach should be taken when interpreting other signs of partial discharge, arcing, or vibration.
